2021

Monroe County Water Quality Study

**Monroe County Planning Commission
Monroe County Conservation District**

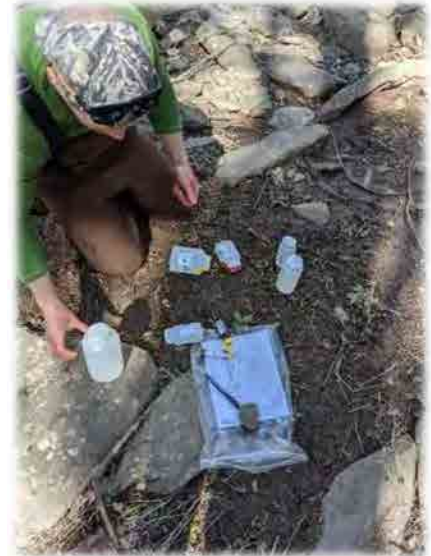
Figure 1: Field chemistry being sampled by Steven Baade, April 2021.

Field chemistry sampling was conducted using a hand-held YSI Professional Digital Sampling System (ProDSS) multiparameter water quality meter. The meter was calibrated to known standards/solutions at the beginning of each sampling day, and the following parameters were collected and recorded on standard data forms at each sampling location:

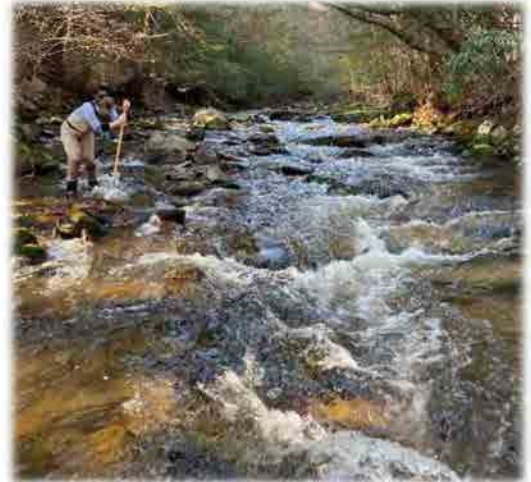
Figure 2: Collecting macroinvertebrates.

Collection of macroinvertebrates began with delineating a 100-meter reach of each sampling location that best represented the habitat of the stream. Collection would be distributed throughout the 100-meter reach and would represent the variety of habitats shown in the bullet points below. In each case, macroinvertebrates were collected using a 12" 500 micron D-frame net that was held downstream from the substrate disturbance. The collection would be moved upstream along the 100-meter reach to limit disturbance of the study area. Six one-minute kicks were used in each of the riffle/run habitats and ten jabs or kicks were used in the multi-habitat locations (*Shull & Lookenbill, 2018*).
