2025

Monroe County Water Quality Study

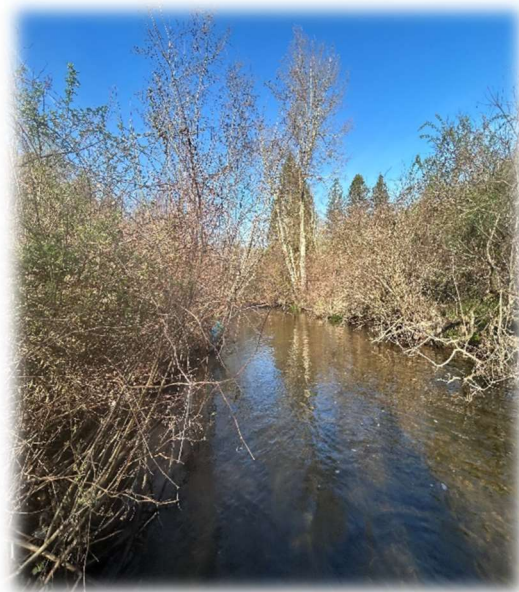
Figure 6: Multi-Habitat/Low Gradient

- Epifaunal Substrate/Available Cover
- Pool Substrate Characterization
- Pool Variability
- Sediment Deposition
- Channel Flow Status
- Channel Alteration
- Condition of Banks
- Bank Vegetative Protection
- Riparian Vegetative Zone

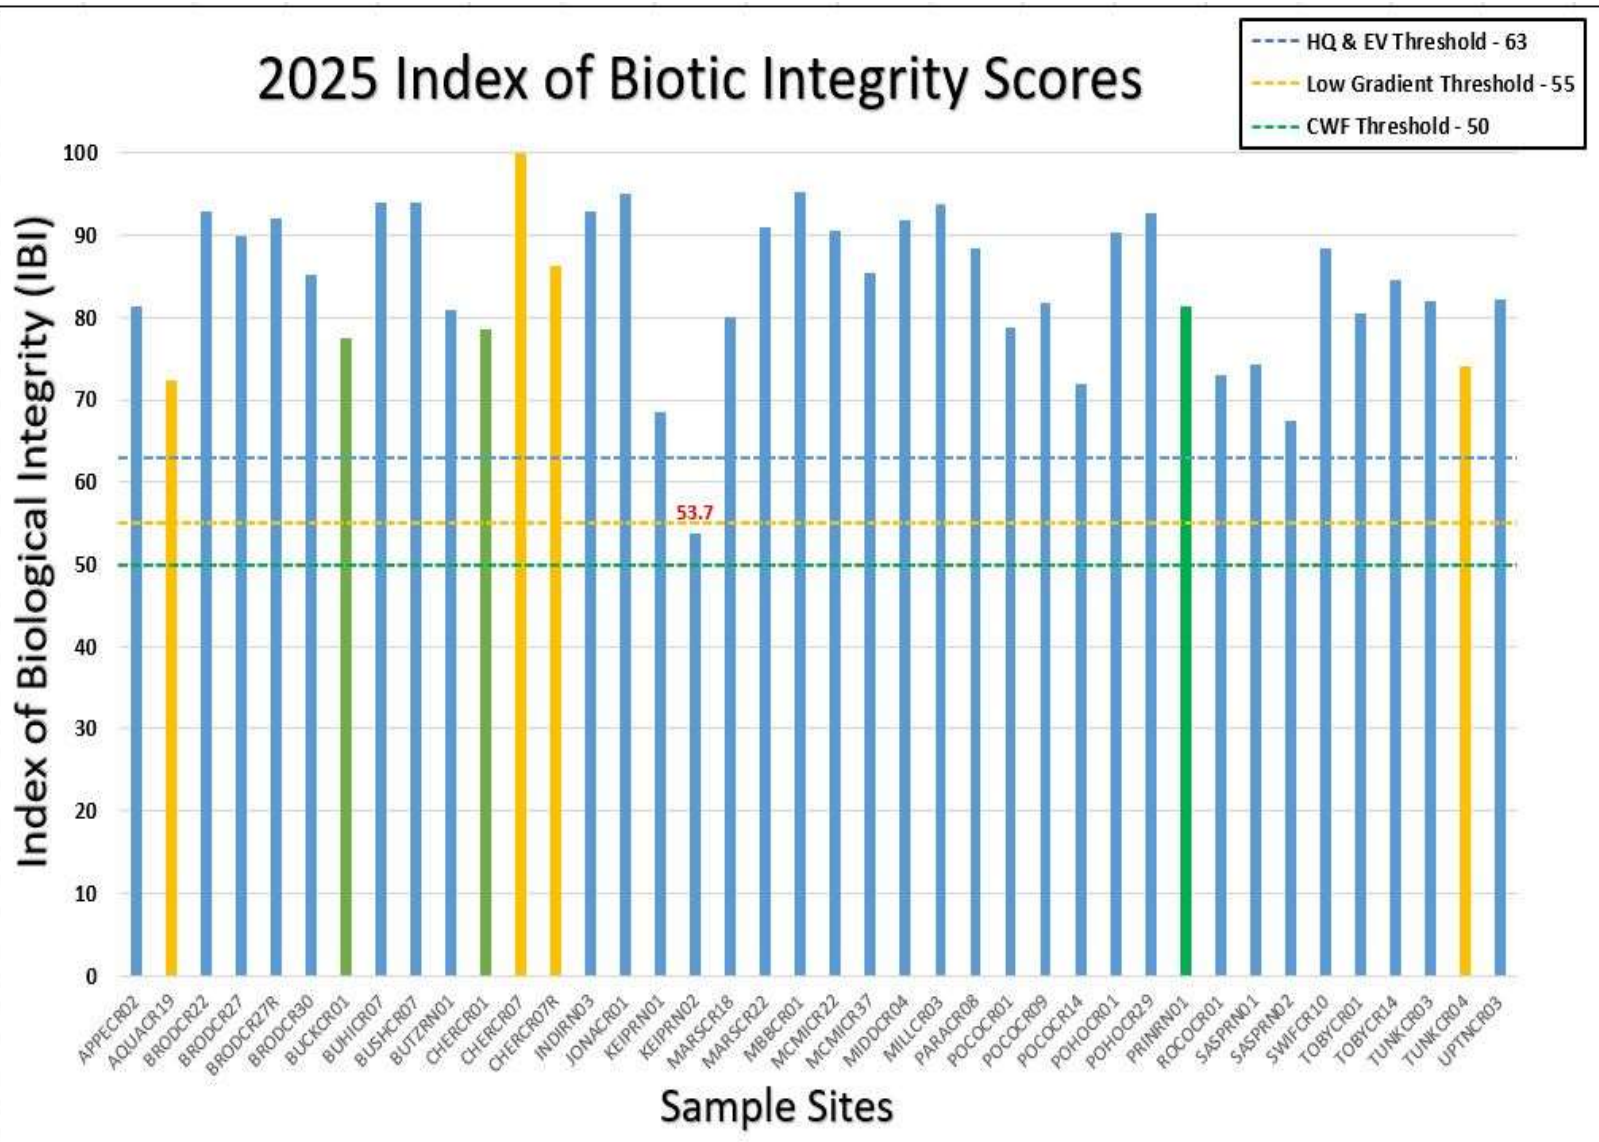
Figure 9: IBI Scores at Monitoring Sites Sampled in 2025

The 2024 IBI scores for the county are shown below in Figure 5, with target lines for the Aquatic Life Use (ALU) impairment thresholds for streams designated as High Quality-Cold Water Fisheries and Exceptional Value (HQ/EV) (Threshold: 63), Low Gradient (Threshold: 55) and Cold Water Fisheries (CWF) (Threshold: 50). Sites scoring below the ALU attainment thresholds are listed below in Table 6. Additional criteria for CWF sites and sites with IBI scores below the ALU attainment thresholds are discussed in further detail on the following pages.

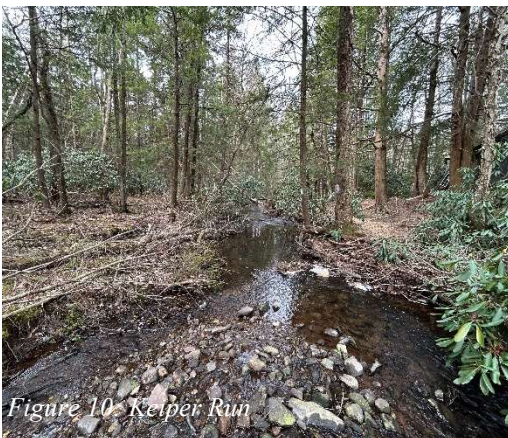
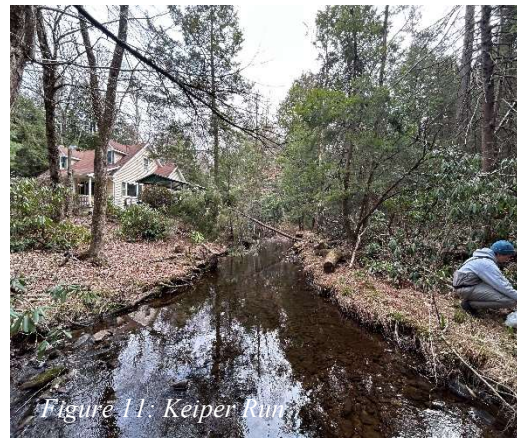
- Land use surrounding the headwaters of Keiper Run have been altered by development.
- In 2019, bank erosion resulted in a large sediment pollution event upstream of the SR 115 Bridge over Keiper Run. Evidence of the discharge is still visible downstream from the road. Parts of the channel are continuing to erode upstream of the bridge.

- Approximately 0.25 miles upstream of the sample site, Keiper Run flows through a low gradient (~1% slope) wetland complex before prevalence of higher gradient riffle/run habitat begins. Low gradient wetlands are optimal habitat for Chironomidae and other filter feeding macroinvertebrates.
